Notes on the Rapid Assessment in Schools affected by heavy rain and strong wind in Rubavu District

4 October 08

The rapid assessment

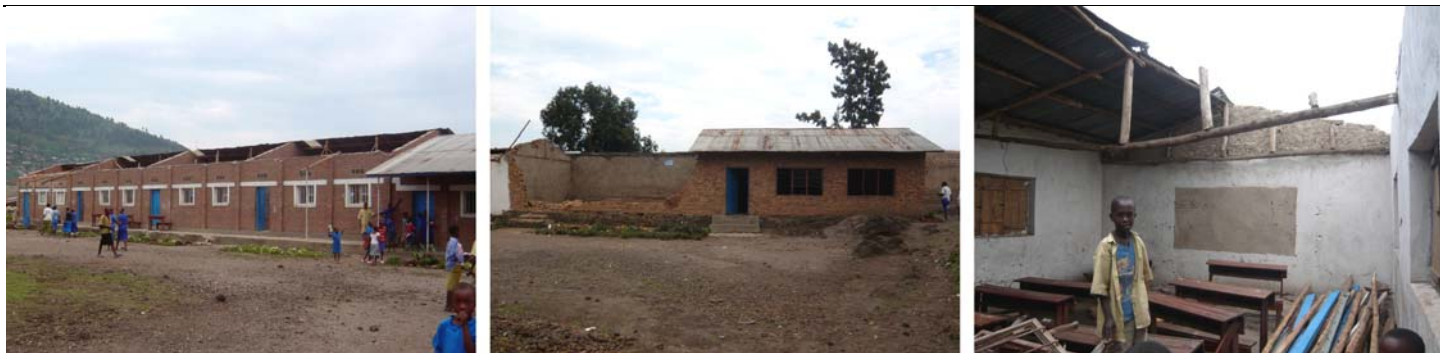
Only two visited schools, Kivumu and Ubumwe present classrooms built with Adobe masonry that should be completely rebuilt with a stronger construction technique for a durable solution.

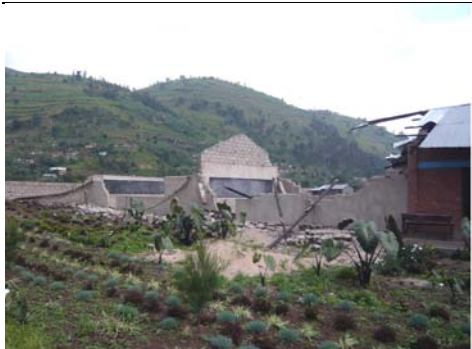
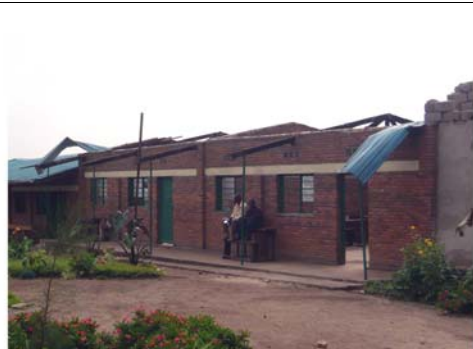
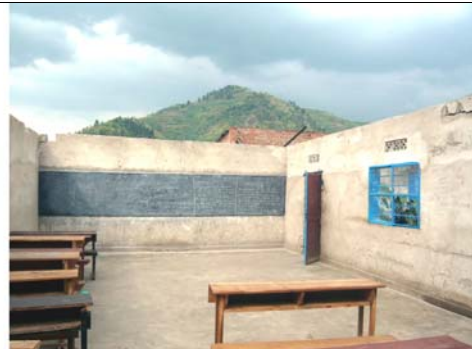
ESBF

Several classrooms have collapse probably because of the poor techniques of construction and the insufficient quantity of cement used for the mortar (i.e. ESBF).
