Notes on the Rapid Assessment in Schools affected by heavy rain and strong wind in Rubavu District

4 October 08

The rapid assessment

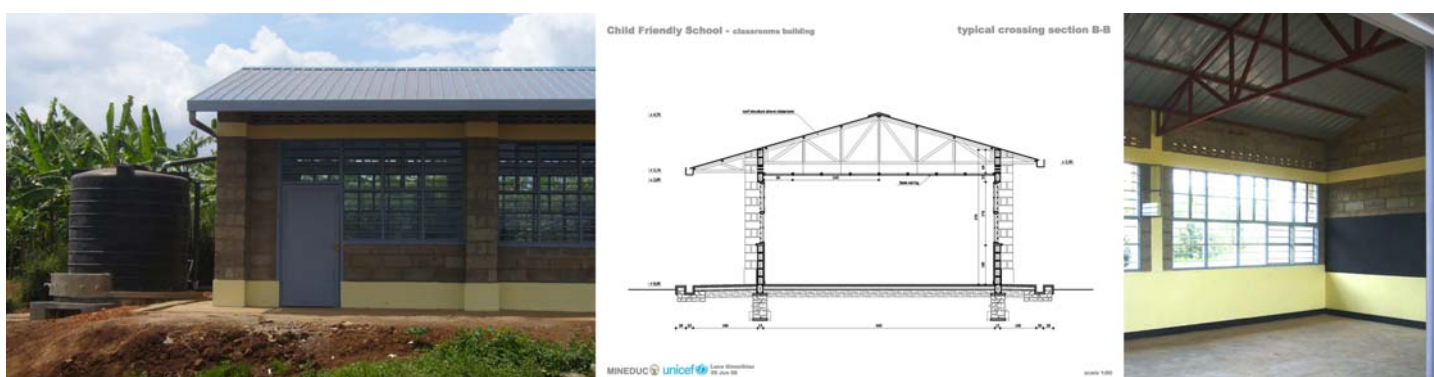
Typical UNICEF Child Friendly School roof metal structure with BG-28 metal sheeting and rain harvesting system

From the above, by reason of existing walls in good conditions and main observed damaged, instead of a temporary solution represented by the simple roof repairing with timber structure and plastic sheeting, **suggested durable solution propose the complete reconstruction of the roof structure with metal square pipes to support good quality metal sheeting as per standard promoted by MINEDUC/UCEFS for Primary Schools construction nation wide.**

Proposed durable solution could also receive the easy future installation of a **rain harvesting system** composed by gutters and water reservoir for those remote areas where piped water supply is not reliable.
